Safetree Safety Alert

Type of incident: Confusing and unfamiliar machinery set up

Date: March 2017

From: SCION – on behalf of Safetree and the Forest Industry Safety Council

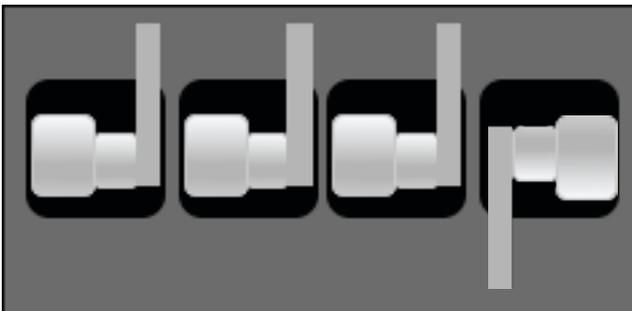
Ground-based operations were conducted during the first two weeks of work while the crew waited for the leased hauler to get out of the workshop. While driving the hauler into the block, the mainline control air pressure function failed which required replacement of the part. The contractor was instructed by the forest management company who owned the hauler to retrieve a spare control part from a nearby Madill 071 hauler and fit it. The replacement mainline control part was back-to-front to the lever set-up in that it secured to the opposite side of the control base with the 'On' position pointing down instead of up (see Figure 1.)

Figure 1. Madill 071 Control Set-up Fitted with Incorrect Replacement Part.

- ▶ It is normal for forestry crews to carry out as much maintenance as possible on equipment to save on costs associated with mechanics.
- ▶ The replacement control lever was visually inconsistent with the other controls (see Figure 1.) and there was no indication of the direction of control activation on the hauler console.

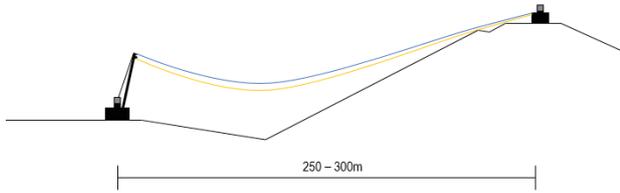
After fitting the spare part, it was understood that it would take about a week for the correct part to arrive during which time operations would continue using the inverse-fitted control lever. For two weeks, cable logging operations proceeded as planned, using a North Bend cable logging approach (Figure 2). The terrain on site was such that there was limited lift for the ropes near the backline bulldozer anchor so it was difficult to get slack to clear the ropes. During the repositioning of the bulldozer, the ropes had become entangled under the slash to the side of the track. The hauler operator made several attempts to clear the ropes using the tight-lining and slacking technique, over a period of roughly 30 minutes. The tree heads that were hooked on the skyline rope were cleared through tight-lining and chainsaw use.

Figure 2. Cable Logging Set-up.

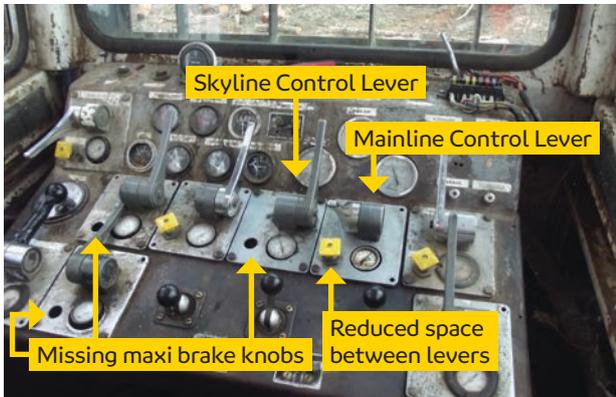
Figure 3. Photograph of the Madill 071 Control Panel.

After hearing the 'hold the ropes' call and assuring all the band brake control levers were in the ON orientation, the hauler operator was sitting and waiting comfortably looking over the control panel out the window. He felt a sudden surge of panic that the mainline brake control lever was in an 'odd' alignment. The hauler operator reached out quickly to remedy this discrepancy and inadvertently knocked or grabbed the skyline control lever which was situated directly beside the mainline control lever (Figure 3). This action disengaged the skyline band brake and triggered the tensioned skyline to suddenly slack. The falling skyline rope stuck the contractor across the shoulders, and he sustained multiple fractures to both legs.

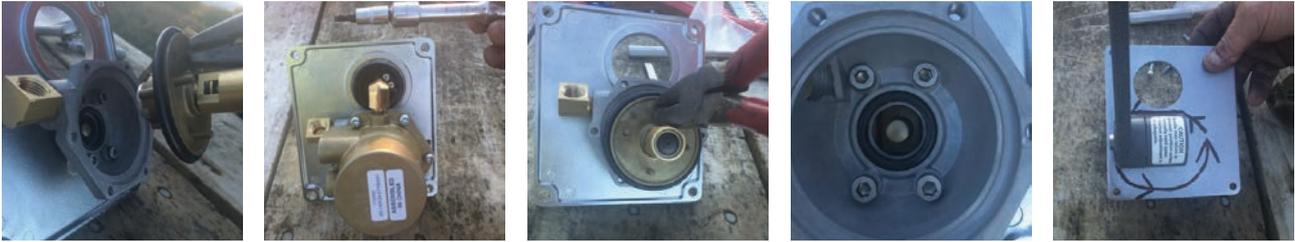
- ▶ The 607 Williams Air Control is an aftermarket lever that allows the fitter to alter the control activation direction. The part is purchased as a package in the default orientation. As the replacement part was borrowed from another hauler owned by the same forest management company, the control level had been adjusted from the default orientation to fit the control arrangement in the second hauler.
- ▶ Crews likely to be undertaking maintenance on the Madill 071 hauler should be aware that the 607 Williams Air Control can be installed in either direction. Installation of the part should assure that the activation orientation is (a) in the direction the hauler operator is familiar with, and (b) in the same position as the other rod toggle levers.

Figure 4. 607 Williams Air Control installation.

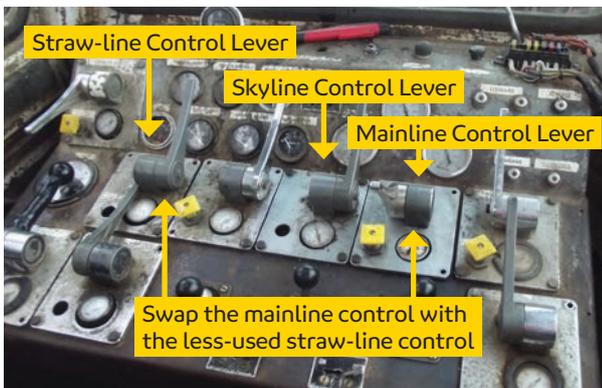
Figure 5. Photograph of the Madill 071 Control Panel.

- ▶ If it is clear the control will be in an inconsistent orientation, it may be possible to swap the mainline control lever with a lever less critical to normal operations such as the straw-line lever. This reduces the visual incongruity and does not disrupt or distort overlearned response schemas, which could result in inadvertent activation or reactions.
