# Safetree Safety Alert

**Type of incident:** Felling machine rollover

**Date:** February 2017

**From:** FISC/Scion

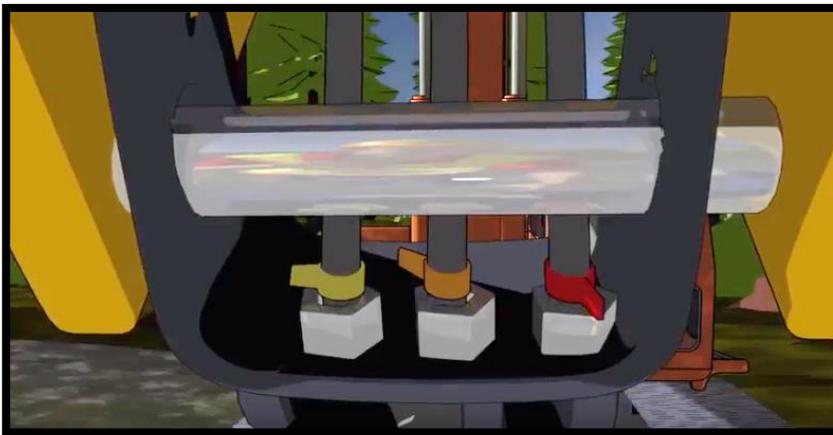
On the day of the incident, the machine operator was first on site at 4.45am. His crew arrived shortly afterwards with a felling head which had been away for repairs. It had put them behind schedule. After their toolbox meeting the machine operator attached the repaired felling head to his machine. The dim morning light made it difficult to see the colour-coded cable ties on the hose fittings and he fitted them the wrong way around.

With the head attached the machine operator started work about 8am. But by 9am the machine broke down again. A sensor joint had blown because of the incorrectly fitted hoses. The machine operator went to find a replacement part then returned at 1.30pm and began to fit the new part. It wasn't until 3.30pm that he was able to get back to work.

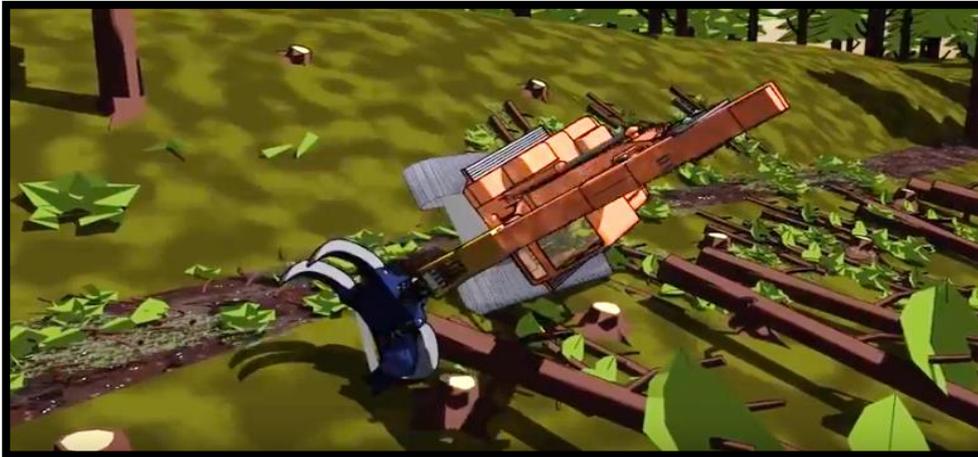
By 4pm the crew had finished all the work they could do and decided to head home. With most of his day spent fixing the machine, the machine operator decided to stay on to get wood on the ground to relieve the pressure for the next morning. Much of the stand was very wet and had a lot of debris in it. Because the slope wasn't very steep the machine operator thought it would be okay to work across it, using an old working road and clearing debris as he went.

By 4.30pm he'd felled about 20 trees and was just about finished. He slewed to the uphill side of the track to fell the final tree of the day. As he reached for the final tree he felt the machine become unstable on the downhill side. He quickly slewed back and dropped his felling head on the ground to stabilise the machine. But it was too late. Felling the previous tree and clearing the track had destabilised the road causing the track to sink. The machine rolled down the bank. Luckily the machine operator was unhurt but the machine was damaged.
