MAXIMISING INCIDENT LEARNING OPPORTUNITIES

Felling Machine Rollover 2017
New Zealand

Maximising Incident Learning Opportunities Incident 3 Felling Machine RollOver 2017

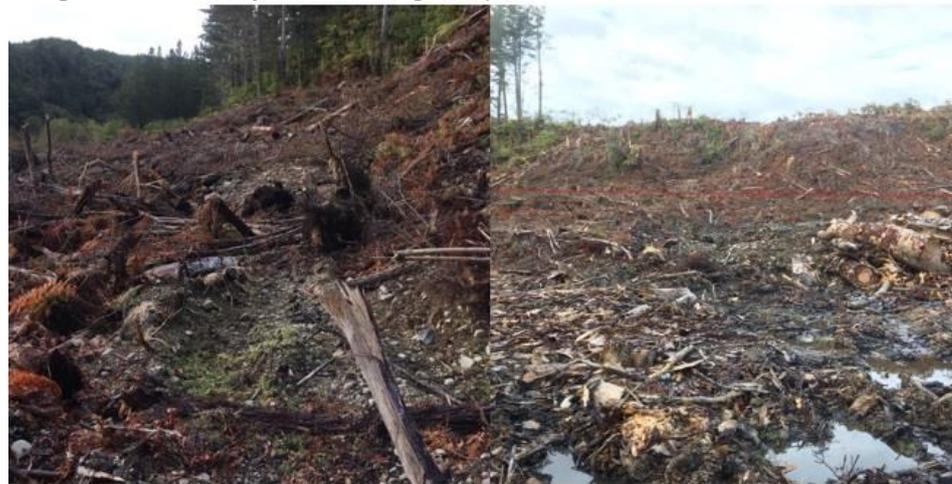
Figure 1. Incident site

Picture: (Left) Old working road looking towards the incident site. (Right) looking towards incident site against the slope, red line indicates old working road; all pictures are post-harvest, taken four months following the incident.

FO considered the flat terrace at the bottom near the road as too wet and had too much debris. FO felt like it was safer to work along the old working road than to work up and down the slope.

FO didn't notice or feel that one of the tracks had sunk in. One side of the working road (the downhill side) was slipping away. "It feels different in the machine to what it looks like on the outside". FO had a gut feeling that "it's on its way over", "started to rear up".

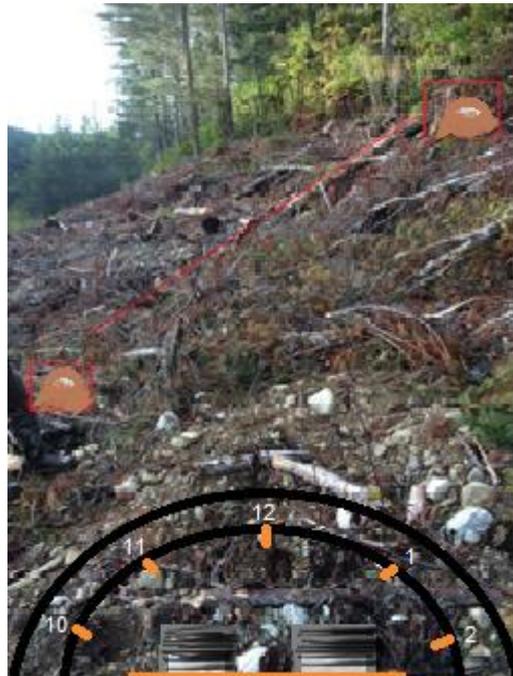
Figure 2. Incident site

With his tracks facing straight ahead (12 o'clock) along the road, the FO proceeded to reach for a tree to his left (10 o'clock). The FO fells the tree and shovels it downhill towards the road (9 o'clock).

The FO then slews to his right (2 o'clock) to drop the final tree in the block. As he reaches for the final tree, the FO felt an instability within the machine. The machine track closest to the hill side was more stable and secure, the other side less so possibly due to the removal of vegetation (Pungas) on the road side for safe slewing. Immediately he tries to correct this imbalance by moving back to facing straight ahead (10 o'clock - as per FO recollection), in an attempt to balance the weight out. The machine continued to roll-over.

The FO managed to turn the machine off during the rolling action, saving it from further damage. The FO could see what he thought caused the rollover upon exiting the machine. Felling the previous tree caused a weight change which destabilised the road causing the road side track to sink. The felling machine track was floating when the FO slewed to cut the remaining tree. The Track would have sunk by only two - three inches until the FO slewed to grab the next tree which the track then dropped one metre. The felling machine was out of commission for a week sustaining damage in the few thousands of dollars. The FO required no medical assistance.

Picture: Old working road looking towards the incident site overlaid with a clock depiction. Red squares with stumps indicate the two remaining trees and the red line in the background indicates the slope depression.
