JNL LEARNING EVENT - #83

COLLISION BETWEEN UTE AND LOG TRUCK

CORRECT RADIO CHANNEL / SEAT BELT USE

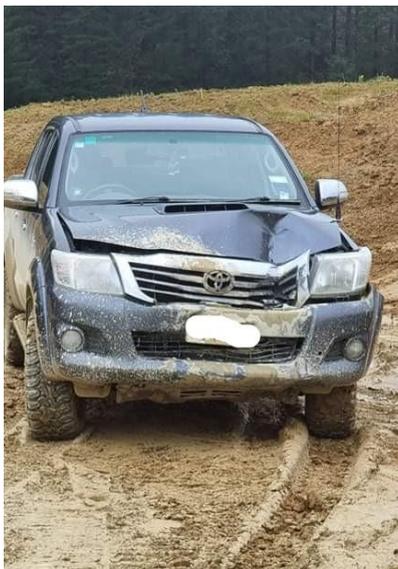
On Feb 8 2022, at approximately 1pm – a ute was driving through an active forest with a fellow worker who he had just picked up. Approximately 2km from the forest exit the ute collided head-on with an empty logging truck. Both vehicles hit the brakes, but with the slippery, muddy conditions and the momentum of the truck going downhill, both vehicles collided.

The logging truck had called his km marker but did not hear the ute call. The vehicles were traveling between 5-10 km/hour. The passenger of the ute was not wearing a seatbelt and sustained an injury (unfit for 3 days).

- The driver of the ute had not switched back to the correct channel.
- As a consequence, the logging truck driver was not aware that another vehicle was travelling in the opposite direction, so went wide around the corner.
- The passenger of the ute was not wearing a seatbelt, and because of this, hit his hand and head on the dash.
- Road conditions were wet and slippery.
- Where the collision happened, there is limited visibility (e.g.: blind corner).
- Narrow road conditions played a role (approx. three metres wide).

- ✓ Ensure staff and subcontractors drive to conditions and wear seatbelts – AT ALL TIMES
- ✓ Do not depend on the radio, drive as if a vehicle could be coming without calling.
- ✓ Ensure staff and contractors know and use the correct radio channels
- ✓ Report missing km markers or road signs
- ✓ Suggest improvements to road signage as needed
