HSE Green Alert 2020

Excavator blind-spot camera

Tohaia Forestry Harvesting Ltd have provided an example of attaining a **safe** operating environment through ensuring systems and practices effectively manage risks

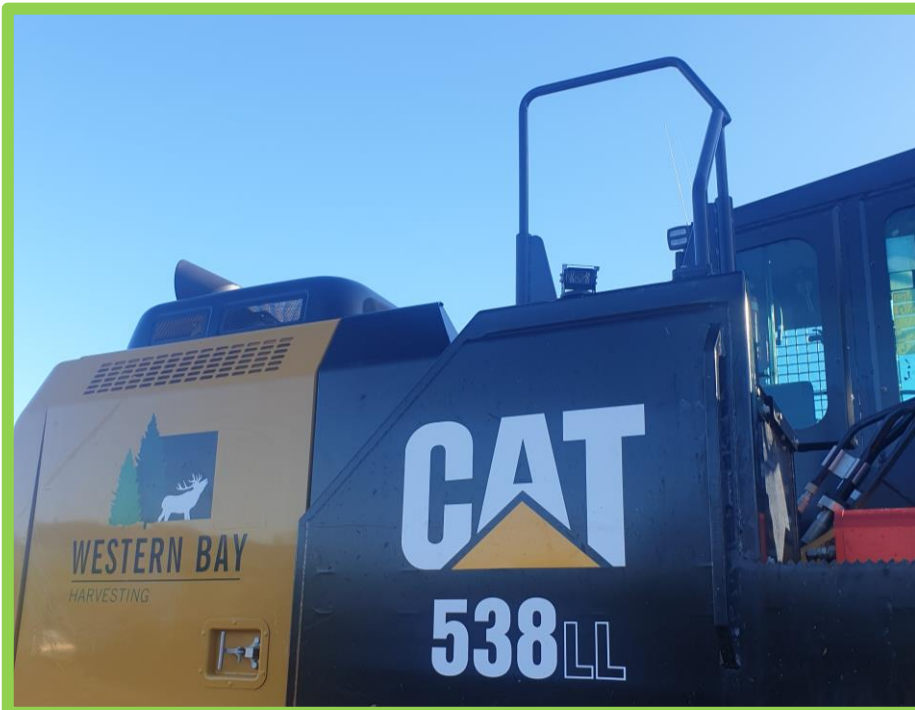
Photo 1: Reversing camera mounted on the outside of the cab.

Mobile plant working on landings often operate in a way that is assumed to be safe. Excavator booms are one of the hazards which can create a blind spot. A mounted camera on the outside with a display inside the cab allows the operator to have more awareness of surrounding operations and activities.

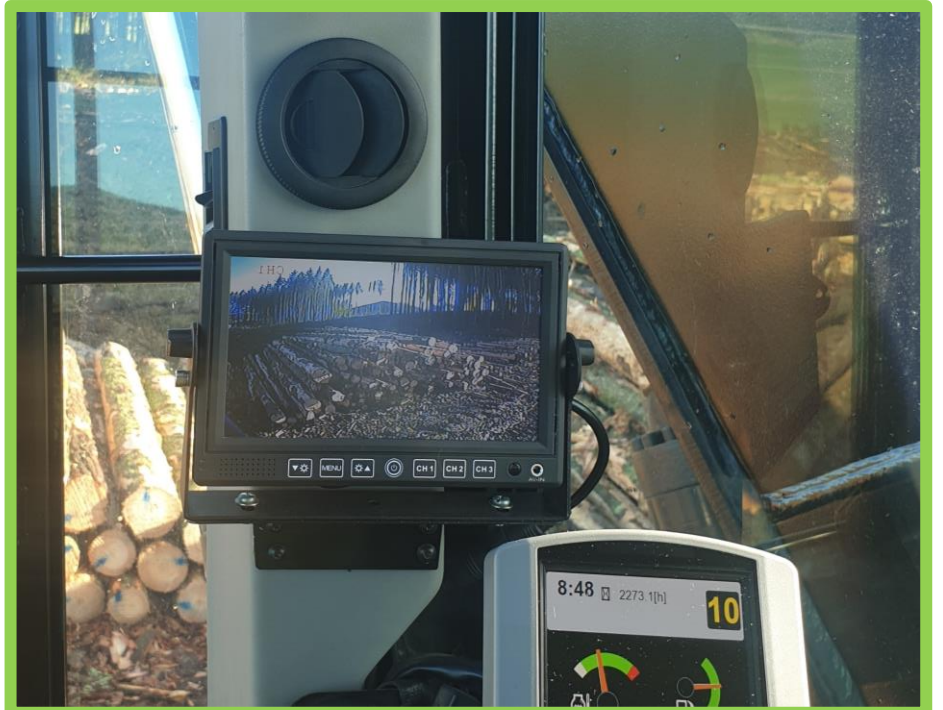
Photo 2: Screen in the cab to manage the risk created by the blind spot
